| CIL Ref. No.: | CIL/20242373 |
| Name of organization: | MEWAR UNIVERSITY |
| Address of premises: | NH - 48 Gangrar, Chittorgarh, Rajasthan-312901. |
| Type of Inspection: | Green Audit |

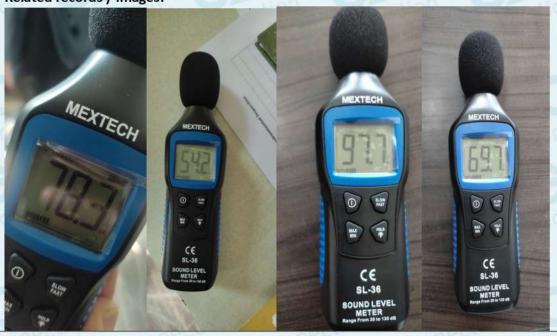
F. Noise meter

Noise Pollution Management (objective, practices / methods to minimize noise pollution) During the CDG Inspection, noise level tests were conducted at various locations within the Institute during the daytime. The measured noise level was found to be 74.975 dB(A) Leq.

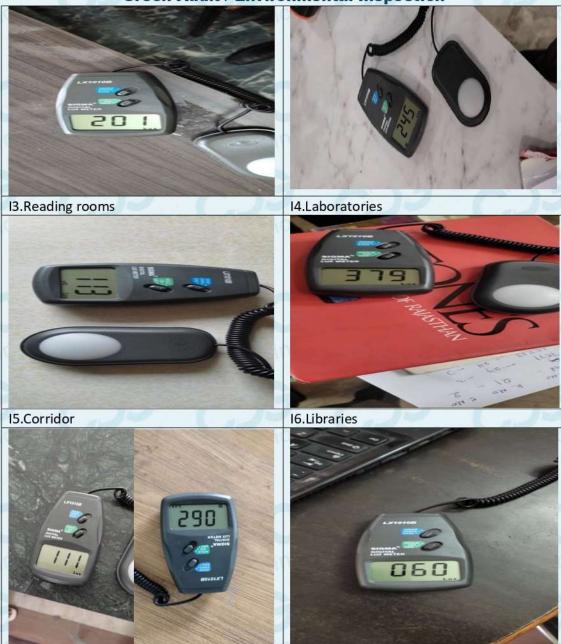
* Recommended illumination Levels and Glare index as per National Lighting Code 2010 [ETD 24: Illumination Engineering and Luminaries] Part 5 Section 3

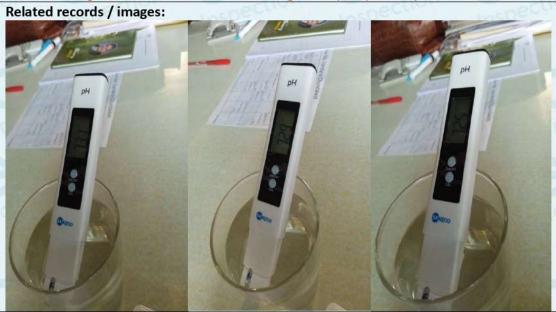
M2. Ph Test

During the CDG Inspection, pH tests were conducted at various borewell locations within the Institute. It was found that the pH of the borewell water is 7.283. These pH values fall within the permissible limits as defined by IS 10500:2012 and confirmed that the water is safe for drinking.

The organization does not conduct drinking water quality test as per IS 10500:2012.

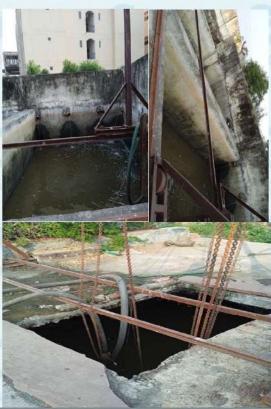
Q2. STP(Sewage Treatment Plant)

| Water Pollution Management (objective, pollution) | practices / methods to minimize water |
|--|---|
| Whether operating STP/ETP satisfactorily? | During the audit, it was found that the Sewage Treatment Plant (STP) was operating satisfactorily, although there is still room for improvement. |
